DEPARTMENT OF TRANSPORTATION**DIVISION OF ENGINEERING SERVICES**

Quality Assurance and Source Inspection

Contract #: 04-0120F4Cty: SF/ALA Rte: 80 PM: 13.2/13.9File #: 1.28**WELDING INSPECTION REPORT****Resident Engineer:**Siegenthaler, Peter**Address:** 333 Burma Road**City:** Oakland, CA 94607**Report No:** WIR-017942**Date Inspected:** 10-Nov-2010**Project Name:** SAS Superstructure**OSM Arrival Time:** 1000**Prime Contractor:** American Bridge/Fluor Enterprises, a JV**OSM Departure Time:** 1830**Contractor:** American Bridge/Fluor Enterprises, a JV**Location:** Job Site

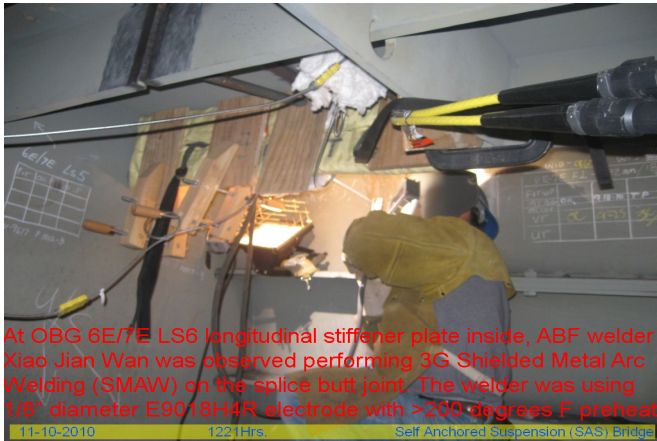
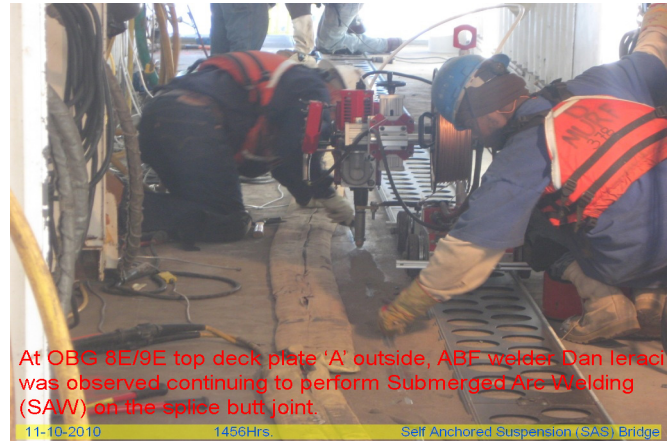
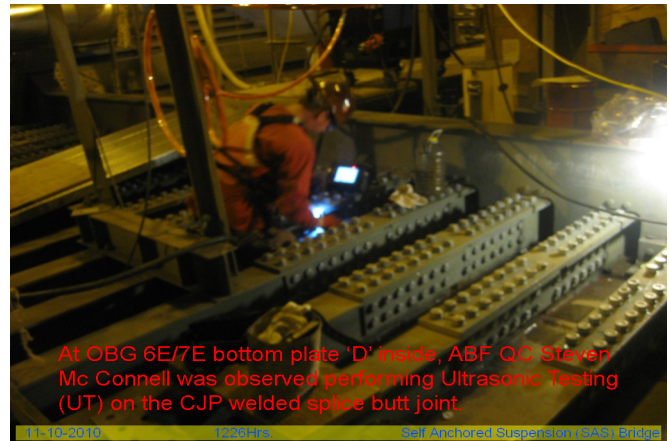
At OBG 6E/7E bottom plate 'D' inside, ABF QC Steven Mc Connell was observed performing Ultrasonic Testing (UT) on the welded splice butt joint. QC was using General Electric USM35 ultrasonic machine. QC was also observed scanning from both sides of face 'A' of the joint. During the shift, ultrasonic testing on the butt joint was still continuing and should remain tomorrow.

At OBG 6E/7E LS6 longitudinal stiffener inside, QA randomly observed ABF welder Xiao Jian Wan ID #9677 perform 3G (vertical) Shielded Metal Arc Welding (SMAW) complete joint penetration (CJP) welding root pass then fill pass on one side of the stiffener splice butt joint. The joint has a double V joint preparation that was welded from one side using E9018H4R with 1/8" diameter electrode implementing Caltrans approved welding procedure specification (WPS) ABF-WPS-D1.5-1012-3. The joint being welded is a high strength plate material HPS 485W which has a thickness of 30mm was root welded using a ceramic backing, and fully welded on one side. The splice joint was preheated and maintained to greater than 200 degrees Fahrenheit using Miller Proheat 35 Induction Heating System heater blanket located at the opposite side of the plate prior/during welding. During the shift, the welder has completed welding cover pass on one side of the stiffener and has moved to the other side. The QA Inspector noted the ABF QC John Paglieri was on site monitoring the in process preheats and welding parameters. During the shift, QA noted ABF QC was closely monitoring the issuance of E9018H4R electrodes due to its limited exposure time allowed. Prior welding, QC and QA performed a joint verification on the fit up

At OBG 7E/8E side plate 'C' (1000mm to 3240mm) inside, QA randomly observed ABF/JV qualified welder Sungtao, Huang ID # 3794 continuing to perform CJP groove welding cover pass on the splice butt joint. The welder was observed performing automatic welding in the 3G (vertical) position utilizing a dual shield Flux Cored Arc Welding (FCAW-G) with E71T-1M, 1/16" diameter wire electrode and implementing Caltrans approved Welding Procedure Specification (WPS) ABF-WPS-D15-3042B-1. The joint being welded had a single V-groove butt joint with backing bar. The splice joint was preheated and maintained to greater than 150 degrees Fahrenheit using Miller Proheat 35 Induction Heating System located at the opposite side of the plate prior/during welding. ABF Quality Control (QC) William Sherwood was noted monitoring the welding parameters of the welder. After welding the cover pass at location 1000mm to 3240mm, the welder has moved to new location 0mm to 1000mm of the same OBG splice. The welder was noted using Shielded Metal Arc Welding (SMAW) at this location due to limited access of the track mounted Bug-o FCAW-G nozzle holder. This location was also completed and again the welder has moved to new location 7900mm to 10555mm. The welder was noted welding root pass using SMAW. At the end of the shift, root pass welding at this location was completed but the fill/cover pass was not done.

At OBG 8E/9E top deck plate 'A1 to A5', QA randomly observed ABF certified welder James Dan Ieraci and Kenneth Chappell continuing to perform 1G (flat position) Submerged Arc Welding (SAW) welding fill pass on the splice butt joint. Welder Dan Ieraci was noted welding from A1 to A3 while welder Kenneth Chappell was welding on A3 to A5. The welders were utilizing F7A6-EM12K-H8, 3.2mm electrode with corresponding Esab OK Flux 10.62 flux and implementing Caltrans approved Welding Procedure Specification (WPS) ABF-WPS-D15-4042B-1. The joint being welded had a single V-groove butt joint with backing bar. The plates were preheated to more than 150 degree Fahrenheit using Miller Proheat 35 Induction Heating System located on top of the plate prior welding and moving it the side during welding. ABF/QC William Sherwood was noted monitoring the welding parameters of welders. QA noted the welding parameters, the workmanship and appearance of the completed fill deemed satisfactory. At the end of the shift, SAW fill pass welding was still continuing and should remain tomorrow.

This QA randomly observed the installation and fit-up of the pipe supports being welded to the embeds of the bent cap located at the W2 west line. The tack welding and field welding was performed by David Garcia ID-8789 utilizing a 3.2 mm electrode as per the Welding Procedure Specification (WPS) identified as Fillet Murex. The 1/4" all around fillet welding was performed in all positions on two miscellaneous channels MC9 x 25.4 (20.5 inches long) to the vertical steel plate embeds of the concrete structure. The inspection was performed by Mike Johnson utilizing the WPS to monitor the welding and to verify the amperage. The fillet welding of the two miscellaneous channels MC9 x 25.4 was completed and inspection of one of the welded pipe support was completed. The other

welded pipe support still needs to be cleaned. ABF sub-contractor F.W. Spencer has been performing the task mentioned above.
